**Work Order Details**

Work Order Number	480949
Work Order Type	Sewer Backup Investigation
Location	3395 LAKEMEADOW CT COLERAIN TOWNSHIP, OH 45239
Requested by:	ELAINE COOPER
Telephone - Home	[REDACTED]
Telephone - Work	[REDACTED]
Customer e-mail	[REDACTED]
Comments	<p>Comments #1: (Copied from Service Request 62902): "Caller: COOPER , ELAINE : Q: Where is the Sewer Backup Occuring? A: Inside Building Q: What is the lowest floor of the building that has a Sewer Backup? A: Basement / Lower Level Q: Are you experiencing a backup now? A: NO Q: How is the backup primarily entering the building? A: Unsure Q: Would you like to request a specific 4-hour window for our response service? A: NO Q: Is this building protected by an MSD-owned pumping system? A: No Q: What type of building is this? A: Single-Family Home Q: Do you know when this specific backup started occurring? A: Yes Q: How deep was the water/sewage at its deepest point? A: Unsure Q: Is there insurance in place to cover this problem? A: Unsure Q: Please enter the Date this back up began. A: 7/14/2023"</p>

SBU Form Pg 1 - Property Status

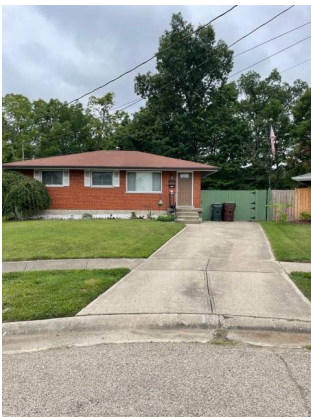
Photo of House

Is the property backed up now?	Did not enter property
Why didn't you enter the property?	Nobody home
Was the property previously backed up?	
Backup Location

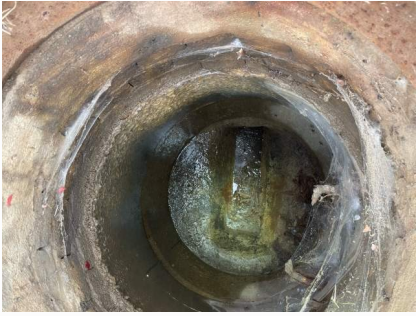
USMH Photo

Upstream Manhole Number 23212002

Upstream Manhole Condition Open and Running

Does the upstream manhole show signs of previous surcharge? No

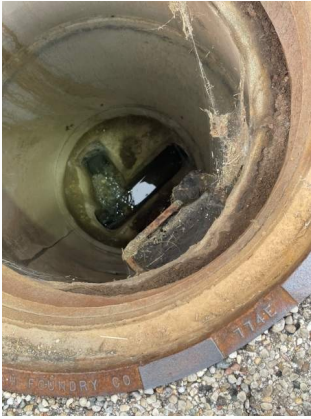
DSMH Photo

Downstream Manhole Number 23212003

Downstream Manhole Condition Open and Running

Does the downstream manhole show signs of previous surcharge? No

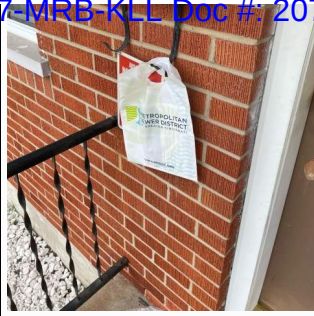
Left packet
